## **SPRINGDALE HISTORIC PRESERVATION COMMISSION MEETING NOTICE AND AGENDA**

**To:** Historic Preservation Commission  
**From:** Thomas Dansie, Director of Community Development  
**Date:** June 19, 2020  
**Re:** June 22, 2020 Historic Preservation Commission Meeting  
Standardized Monument Design Using Historic Irrigation Ditch Stone

# STONE MONUMENT DETAIL

**UTAH STATE ROUTE 9  
WORKS PROGRESS  
ADMINISTRATION**

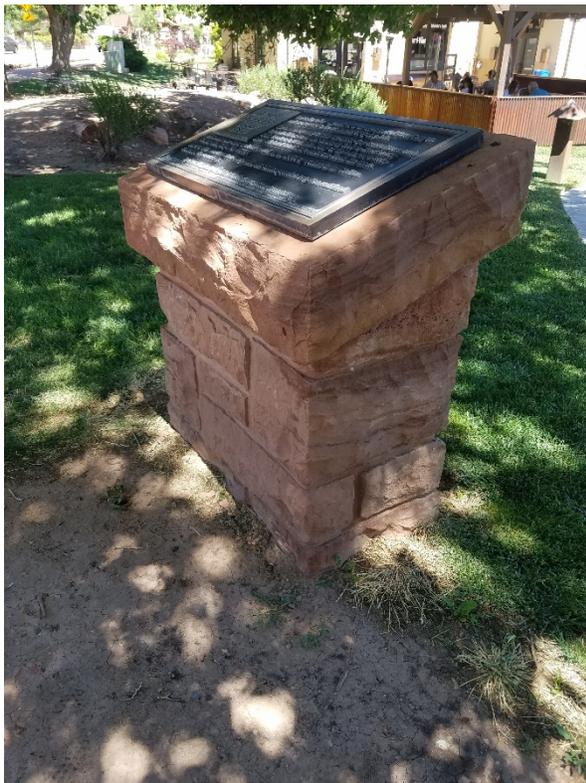
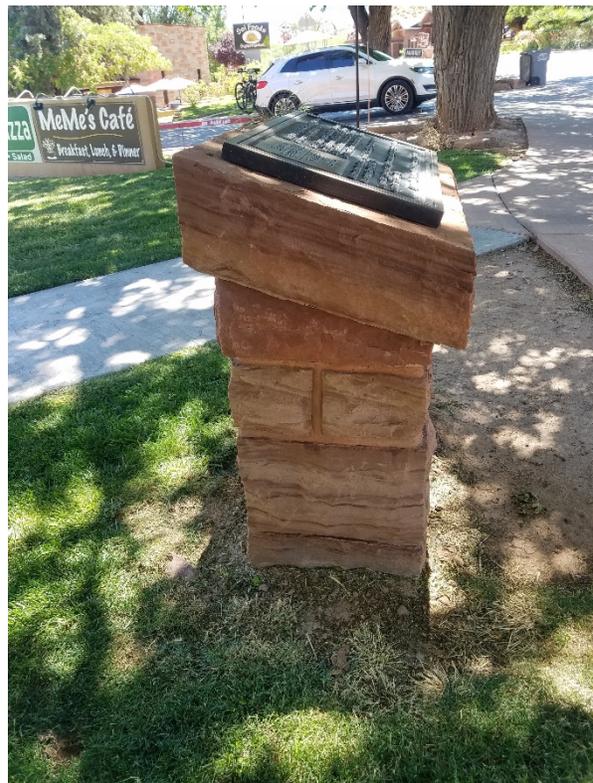
As mentioned above, UDOT was required to install a stone monument commemorating the historic stone lined ditches. The monument is located under the mulberry trees on the lawn in front of Meme's Café. Details of the monument are attached. Photos are shown below.

Staff suggests using this stone monument as a standard template for future stone monuments in the Town. The size of the monument would adjust to accommodate differing locations and plaque sizes; however, the general design would remain constant. Doing so will create a consistent look for monuments throughout the Town. When a person sees the standard monument style, they will know the monument contains a plaque commemorating something of important historic or cultural significance.

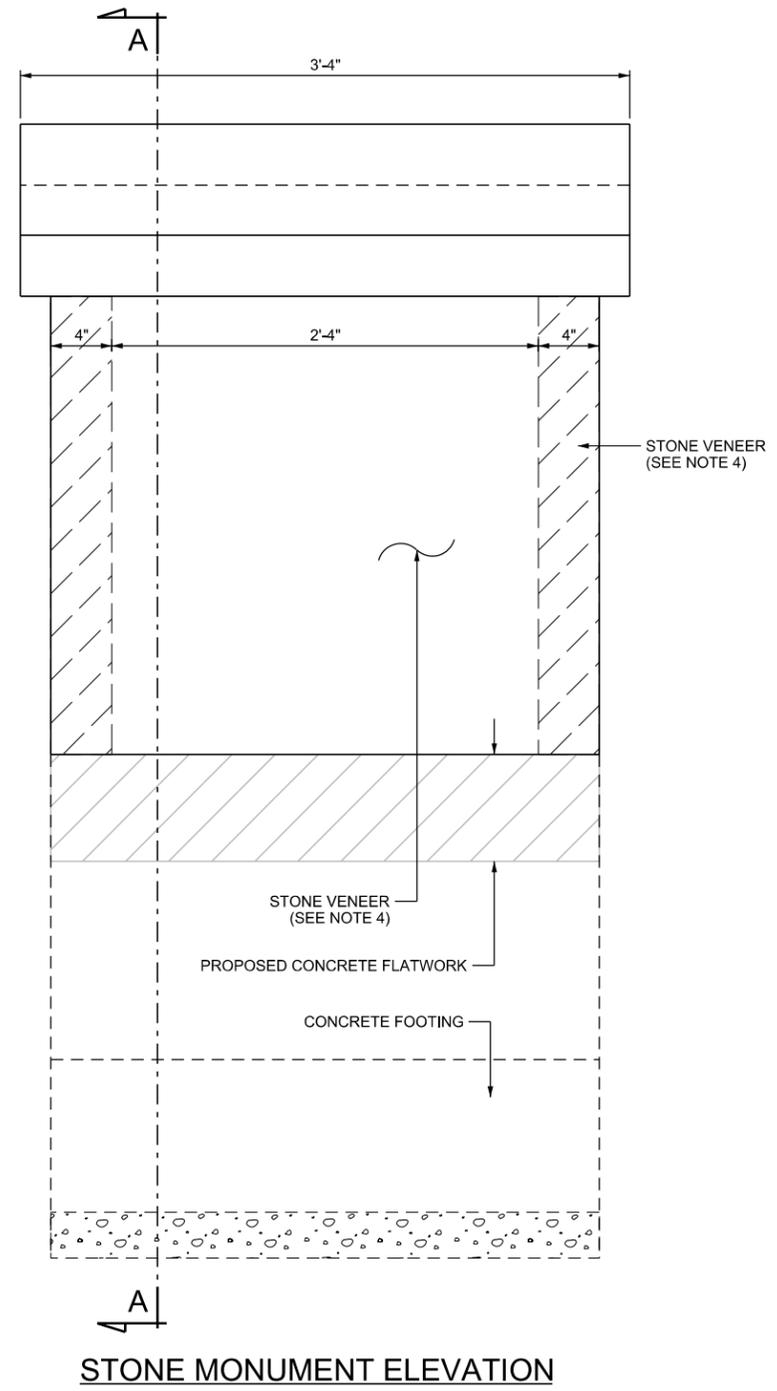
- NOTES:**
1. USE CONCRETE CLASS AA(AE) PER SECTION 03055.
  2. ALL REINFORCING STEEL TO BE EPOXY COATED PER SECTION 03211
  3. ALL CAP STONES TO BE FULL WIDTH OF THE WALL
  4. SEE DT-11 FOR STONE MASONRY PATTERN.

OVERHANGING CAP STONE TO BE 4" (± 1/2") THICKNESS X 18" MIN. LENGTH (LENGTH TO VARY). CAP STONES MAY BE LESS THAN 18" WHERE SHOWN. ALL CAP STONES TO BE FULL WIDTH OF WALL

STAGGER OVERHANGING CAP STONES SO THAT JOINTING DOES NOT ALIGN WITH WALL JOINTING. SEE SONE WALL SECTION FOR INTEGRAL CAP STONE DETAILS.

WITHIN ANY GIVEN PLANE NO VERTICAL JOINT SHALL EXCEED 3 STONES 16" OR 2/3 HT. (WHICHEVER IS THE LEAST) OF THAT PLANE.

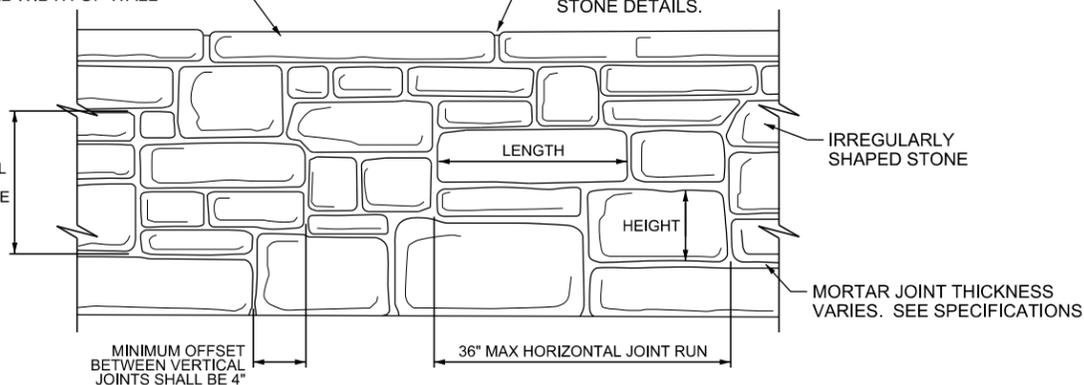
**STONE MASONRY PATTERN**

1. MIN. STONE HEIGHT: 2 1/2"
  2. 75% OF ALL STONES TO BE HORIZONTAL. (LENGTH DIMENSION GREATER THAN HEIGHT)
  3. 75% OF ALL STONES TO BE 8" - 24" IN LENGTH.
  4. UP TO 15% OF ALL STONES SHALL BE IRREGULARLY SHAPED (NOT SQUARE OR RECTANGLE)
  5. DRESS STONE FACES TO ACHIEVE GENERALLY CONVEX RELIEF
- RELIEF TOLERANCES:  
 2 1/2" - 10" AT 3/4" ±  
 10" - 12" AT 1 1/2" TO 2"  
 12" - 16" AT 2" TO 2 1/2"
6. MORTAR JOINTS SHALL GENERALLY BE LEVEL AND PLUMB. IRREGULARLY SHAPED STONES ACCEPTED.

HEIGHT	LENGTH
25% OR LESS	2 1/2" - 4"	4" - 24"
15%	12" & GREATER	10" - 36"
60%	4" - 12"	4" - 36"

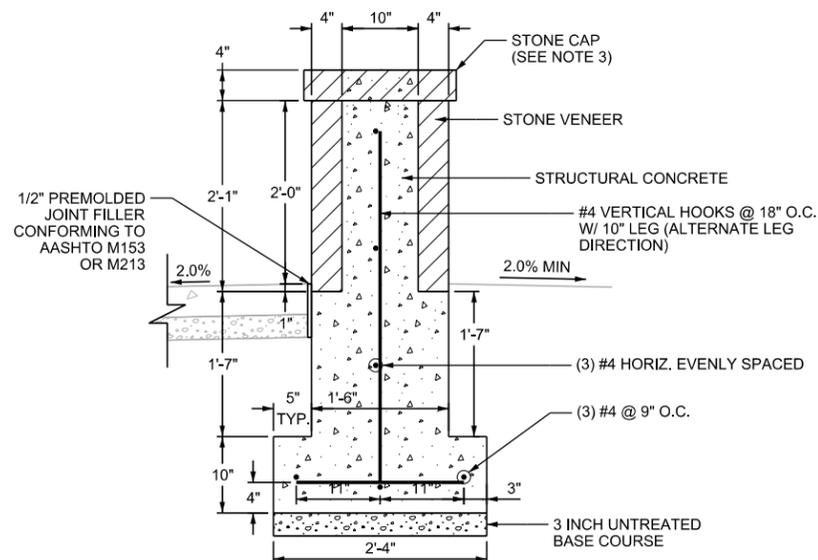
**STONE SEATWALL DETAIL**

1. USE CONCRETE CLASS AA(AE) PER SECTION 03055.
2. ALL REINFORCING STEEL TO BE EPOXY COATED PER SECTION 03211
3. ALL CAP STONES TO BE FULL WIDTH OF THE WALL

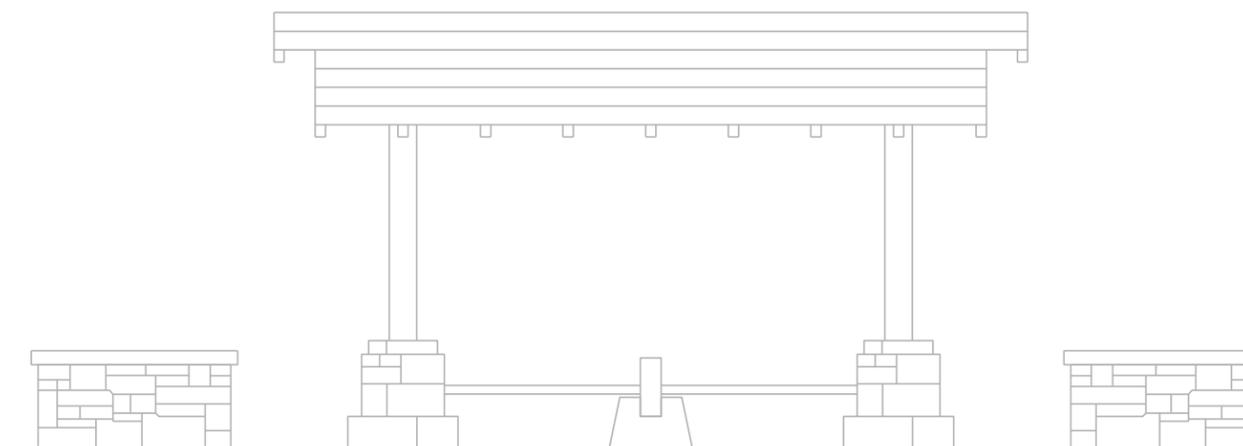
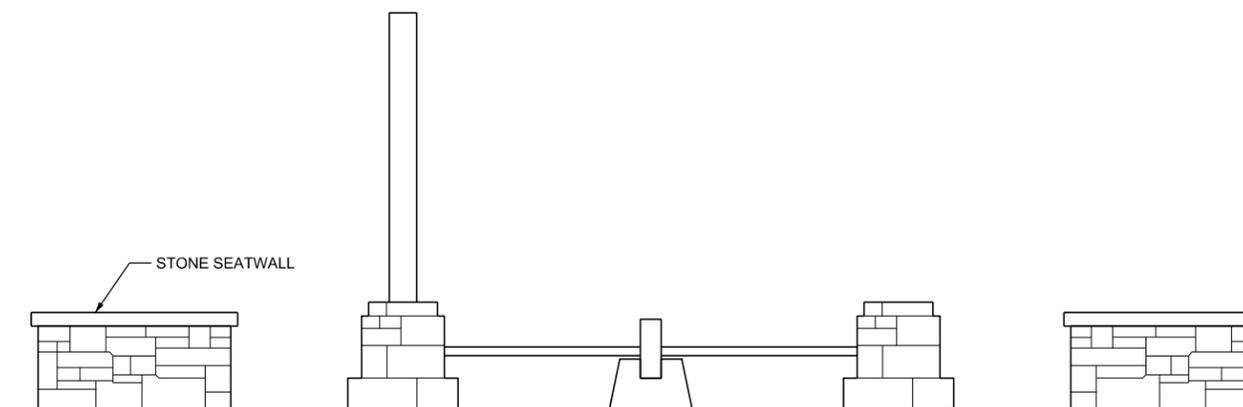
**RELOCATE BUS STOP ELEVATION DETAIL**

**EXISTING BUS STOP ELEVATION**

**RELOCATED BUS STOP ELEVATION**

1. RELOCATE OR RECONSTRUCT ALL REQ'D ELEMENTS. REMOVE AND DISPOSE OF UNUSED ELEMENTS OF THE EXISTING BUS STOP.
2. REFER TO SHEETS DT-11A TO DT-11C FOR THE DESIGN OF THE EXISTING BUS STOP STRUCTURE.

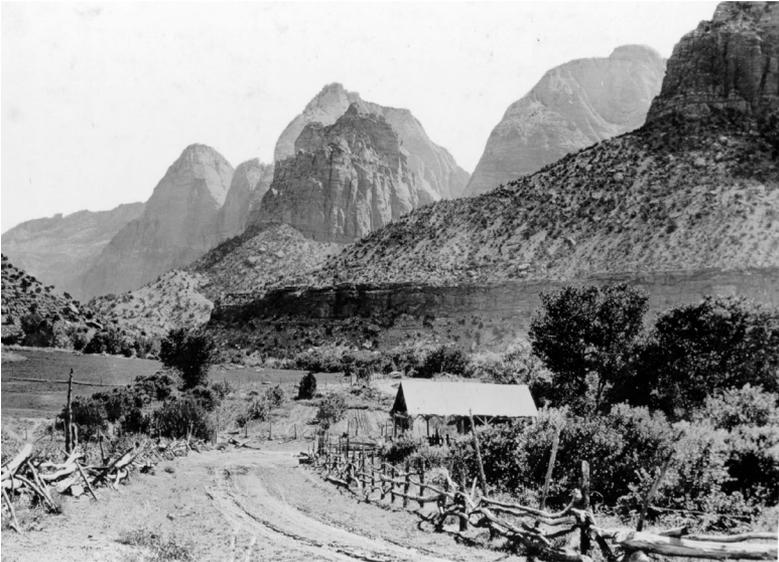
**Figure 1.** Road through Springdale, ca 1880s. View to the northeast.  
(Photograph courtesy of Southern Utah University Special Collections.)

Travel into the east Virgin River Valley was limited to this gradually improved wagon road throughout the 1800s and the first two decades of the 1900s. In 1916, the route was added to the state highway system and in the 1920s, was designated State Route 15, Farm Access Road Number 14 (Knowlton 1963). It was not until 1977 that the road was re-designated as SR-9 to avoid confusion with the newly constructed Interstate 15. **Figures 1, 2, and 3** below illustrate the conditions of the road corridor at the same location in Springdale during the 1880s, 1915, and 1938.

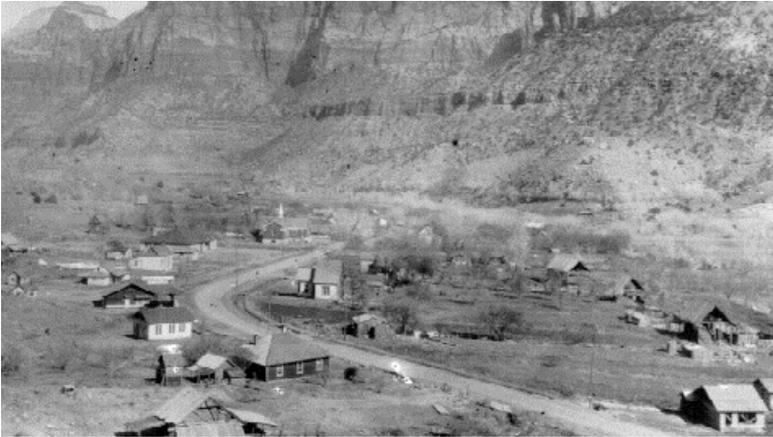
**Figure 3.** Road through Springdale, ca 1938 after the 1926 improvements but before the improvements of 1940 to 1941. View to the northeast. (Photograph courtesy of Southern Utah University Special Collections.)

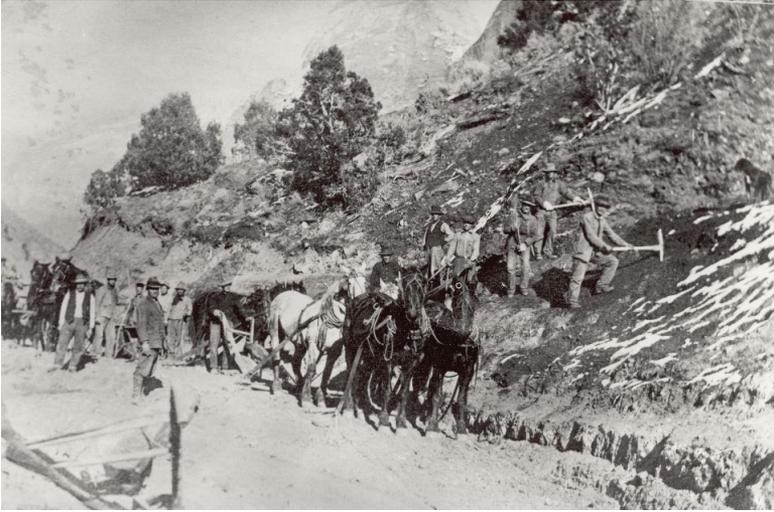
**Figure 4.** Construction on the road to ZION, probably early 20th century. (Photograph courtesy of Southern Utah University Special Collections.)

then, road maintenance was the purview of county crews who graded the dirt roads using horse-drawn, split-log drags that leveled the road surface (**Figure 4**).

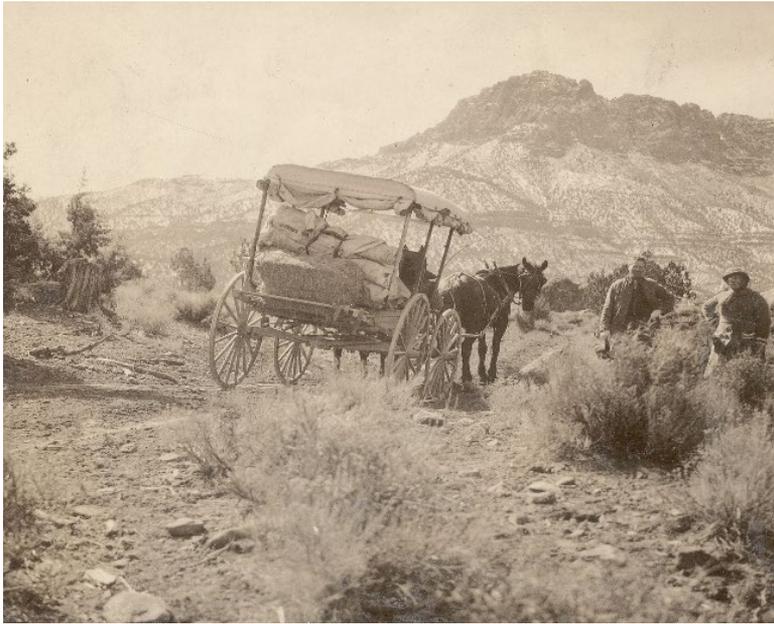
**Figure 5.** A mountain buggy in use near Rockville. (Photograph courtesy of Southern Utah University Special Collections.)

These muddy roads were quickly rutted by the narrow-wheeled wagons of the period. Specialized “mountain buggies” and reinforced freight wagons were developed to handle the unusually rough conditions (**Figure 5**). In 1917, road improvements were made by convicts from the Utah State Prison in Salt Lake City (Whalen 2012).

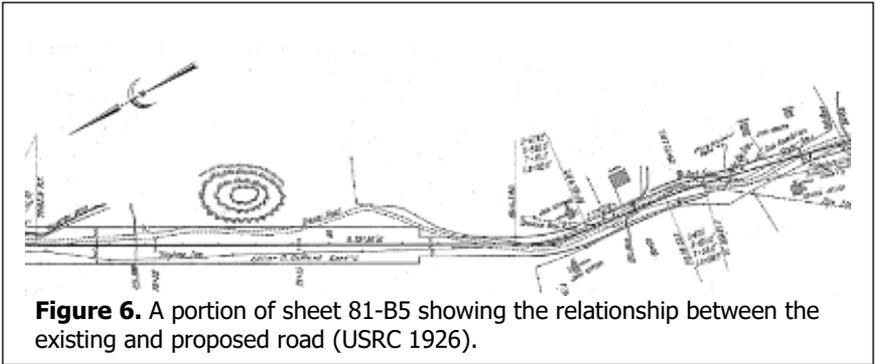
**Figure 6.** A portion of sheet 81-B5 showing the relationship between the existing and proposed road (USRC 1926).

Extensive improvements were made to project 81-B in 1926. Two plan sheets (USRC 1926 [sheets 81-B4, 81-B5]) have been located for this project; these extend from the ZION boundary to near the current center of Springdale. Prior to 1926, the road appears to have been an approximately 16-foot-wide dirt road that wound crookedly to avoid boulders, irrigation canals, and steep topography (**Figure 6**). A stone fence ran along the east side of the road through Springdale.

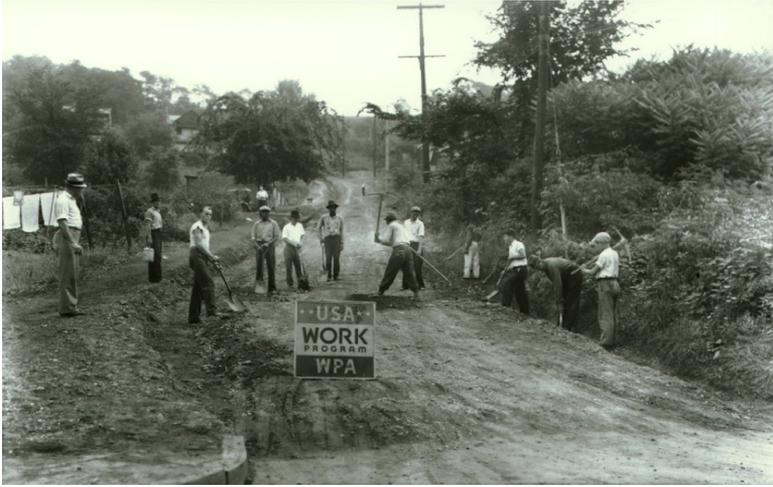
**Figure 7.** A WPA road improvement project in the Southeast, ca 1939. (Photograph courtesy of the U.S. National Archives.)

and often also trucks, tools, and supplies, with the WPA responsible for wages (and the salaries of supervisors, who were not on relief) (Howard 1943). The labor force lived locally or else were responsible for providing their own room and board; contrary to the CCC, there were no man camps provided in the WPA (Smith 2014) (**Figure 7**).

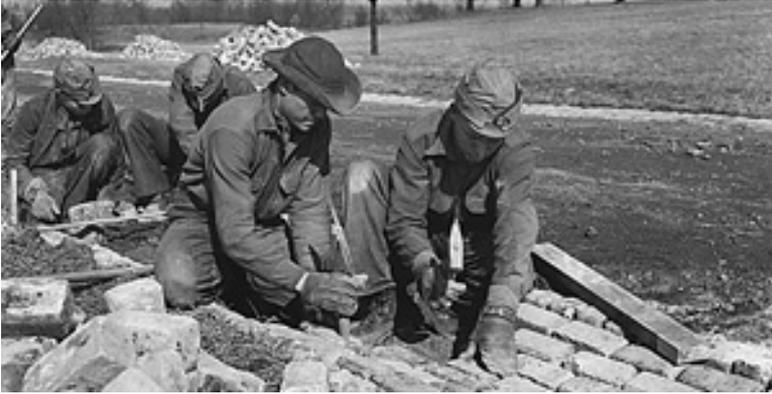
**Figure 9.** CCC laborers being trained in the construction of masonry curb and gutter. Location unknown. (Photograph courtesy of the U.S. National Archives.)

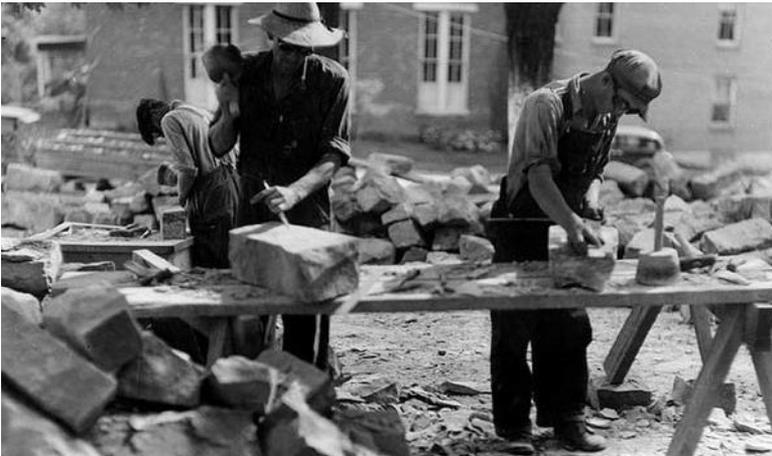
**Figure 10.** WPA masons chiseling pitched-faced sandstone blocks in Grayson Kentucky. (Photograph courtesy of the U.S. National Archives.)

Stone masonry associated with CCC and WPA projects had a number of typical characteristics, including high-quality work with large, pitched-faced blocks and wide, recessed pointing (**Figures 10 and 11**). Alternating different colored rock within the same structure was often done in a style that might be considered garish today (Smith 2009). All of these characteristics are visible in the WPA SR-9 work.

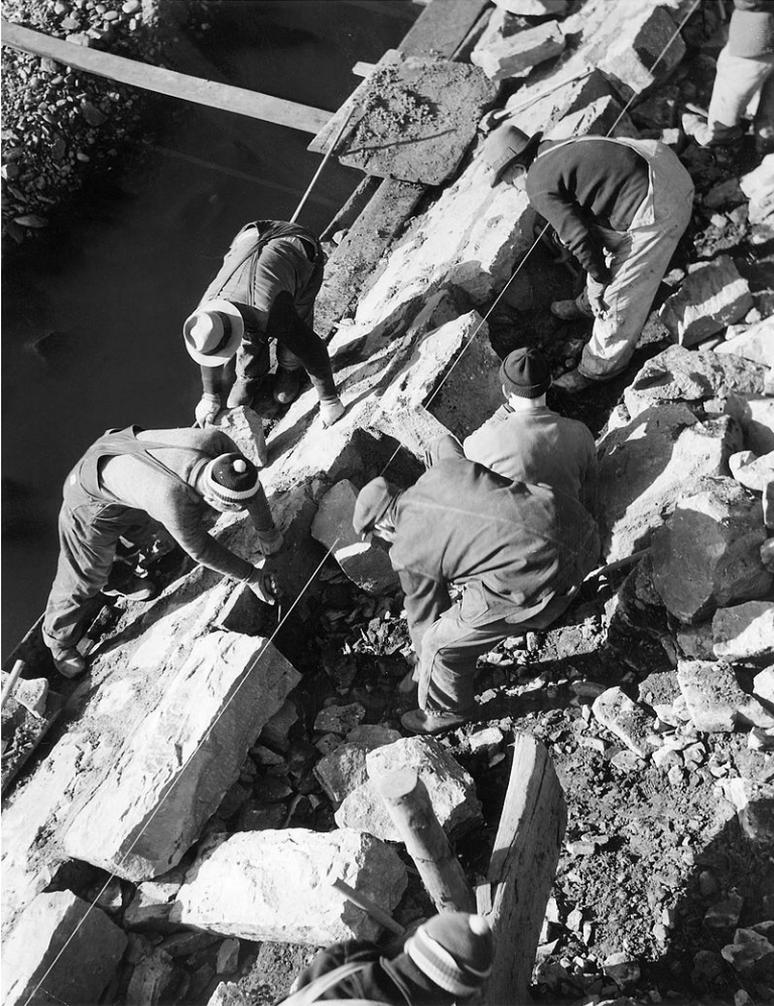
**Figure 11.** WPA laborers lining a roadside canal in the State of Washington. (Photograph courtesy of the U.S. National Archives.)

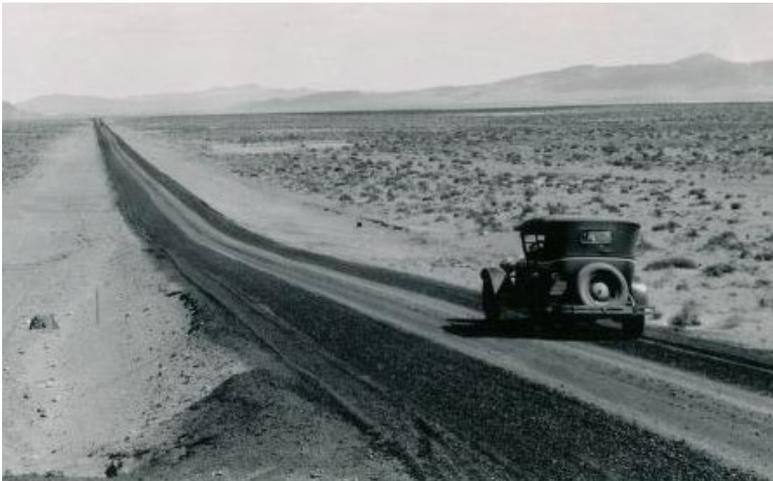
**Figure 16.** Newly constructed oiled gravel road near Fernley, Nevada, ca 1927. (Photograph courtesy of the U.S. National Archives.)

Using mixed oil and gravel to form compact roadbeds became very common in the Southwest around the turn of the century after the discovery of oil in California (**Figure 16**) (Pierre 1998). This paving method is explained in the following 1907 article excerpt:

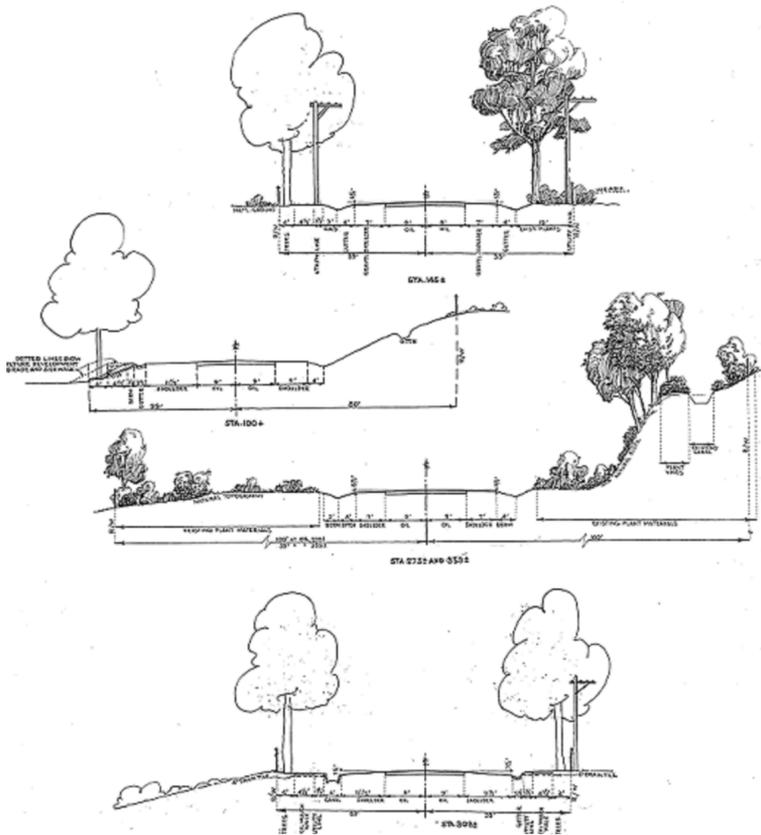
**Figure 17.** Typical project road cross sections. From the top these are: 1) a level area outside of town; 2) a moderate slope outside of town; 3) a steep area outside of town with adjacent irrigation canal; and 4) a level area in town with landscape plantings, sidewalks, a “rock canal” on the left, and “curb and gutter” on the right (USRC 1938 [sheet 81-B3 2]).

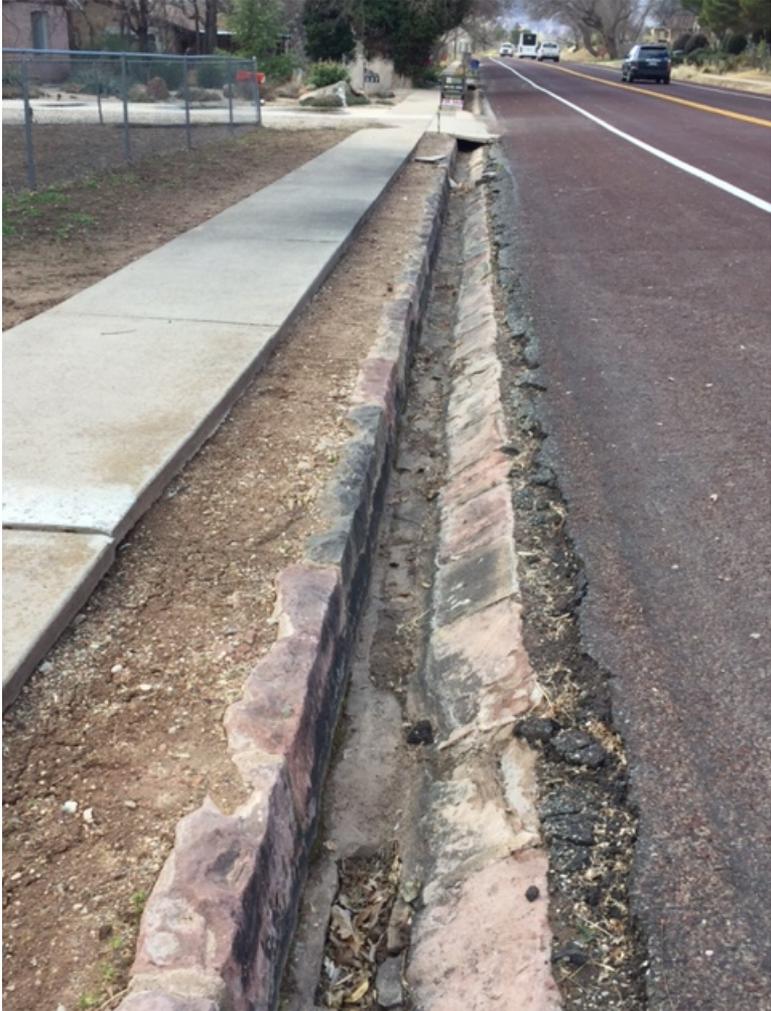
**Figure 18.** Example of “curb and gutter” Type B in Rockville.

The most common style, designated here as Type B (**Figure 18**), is referred to as a “gutter” in Springdale (USRC 1938 [sheets 81-B3 3, 81-B3 4]) and “curb and gutter” in Rockville (USRC 1938 [sheets 81-B3 7, 81-B3 8]). Type B is asymmetrical with sandstone walls and bottoms. The side farthest from the road is 12 inches high and vertical. The side adjacent to the road is angled at approximately 40 degrees, with the top level with the road asphalt, which is 5 inches lower than the opposite side. This higher, exterior wall presumably constitutes the “curb.” The level bottom is 7 inches wide. When the thickness of the masonry blocks is taken into account, the total width of the Type B gutter is 26 inches. Four-inch-

diameter ceramic pipes drained water from the ditch to the roots of the fruitless white mulberry trees that had been planted along the exterior of the new sidewalks.

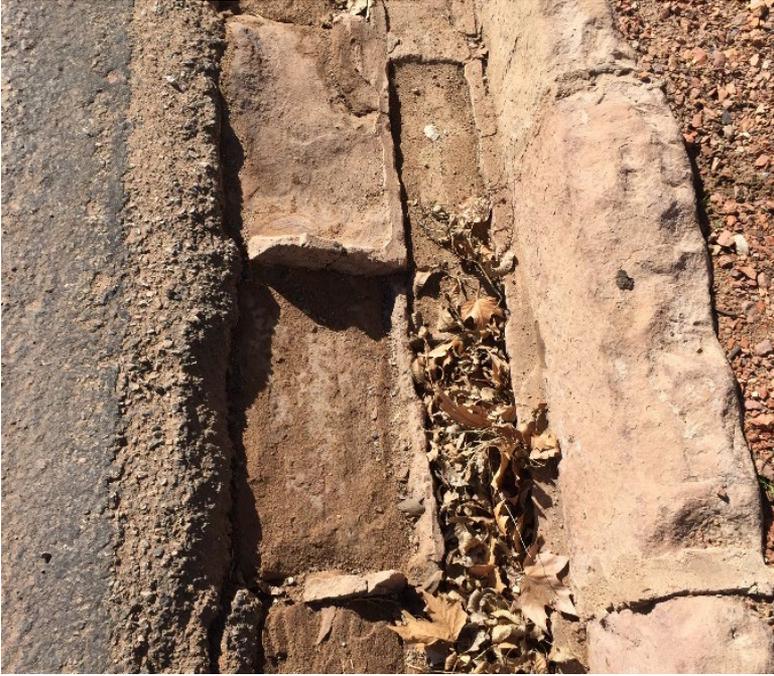
**Figure 19.** Highly eroded Type B gutter, Springdale.

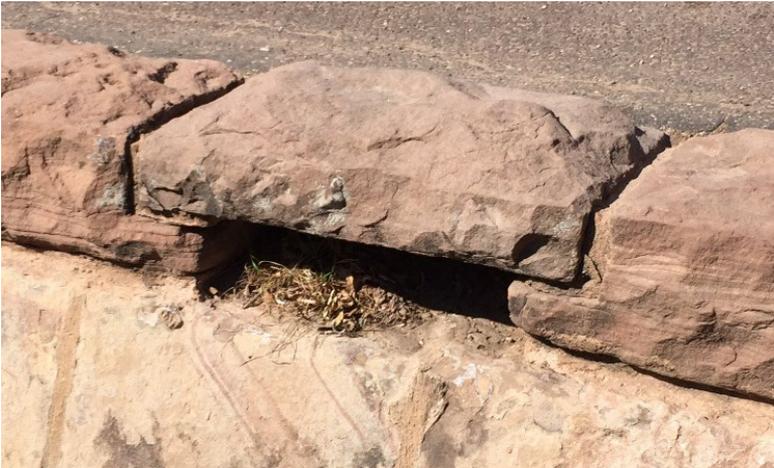
**Figure 20.** Type D capstones and drain, Springdale. Note the pitched faces of the capstones.

Another style, designated Type D (**Figure 20**), is a large, rectangular ditch found in both Rockville and Springdale, referred to as a “rock canal” in Springdale (USRC 1938 [sheet 81-B3 4]) and “rock-lined canal” in Rockville (USRC 1938 [sheet 81-B3 8]). Type D ditches, the largest and most ornate of the feature types, are made of large, square sandstone blocks. The sides are each 2 feet high and canted outward approximately 3 inches; the level base is 3 feet across. These blocks are 8 inches thick, compared to the 6-inch-thick blocks used for Type B and C features. Along the roadside of the canal, capstones were used to prevent vehicles from driving into the canal. These capstones average 10 inches high, 18 inches wide, and 16 to 30 inches long; they tend to alternate the use of pink and lavender sandstone, which would have been much more pronounced when the rock was freshly quarried. The surface of each block has been pitched, with a clearly defined outer edge and a face roughly cut with a pitching chisel. At periodic distances, roadside drains have been installed beneath the capstones (**Figure 21**).

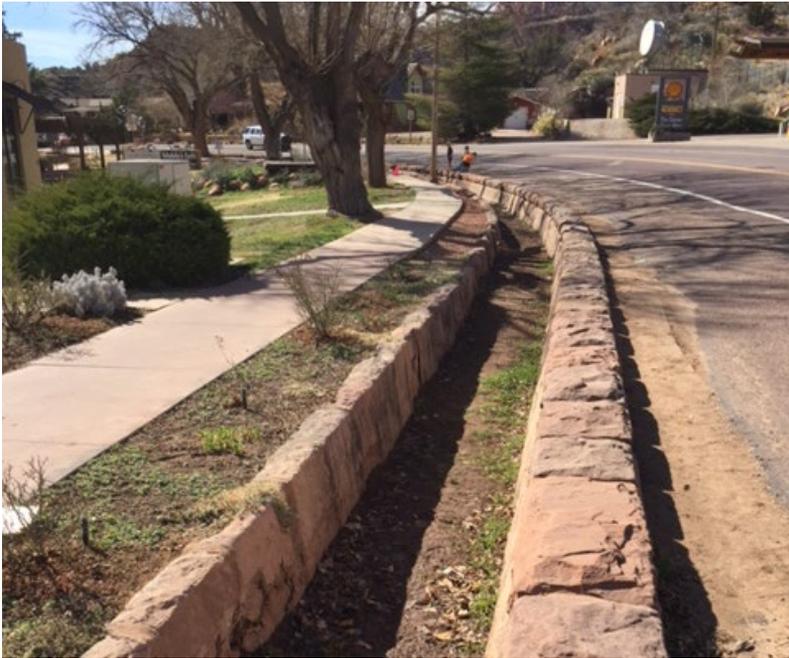
**Figure 21.** Example of a “rock canal,” Type D, Springdale. Note alternating colored capstones.

In Springdale, 619 feet of Type D were present on the left side of the road. In Rockville, 570 feet were present, also on the left side, although the capstones had all been removed along a 215-foot segment. In Rockville, the Type D canal is currently utilized by the Rockville Town Ditch Company for transporting irrigation water. In Springdale, the Type D canal was used by the Springdale Consolidated Irrigation Canal Company to transport irrigation water between 1941 and the late-1970s; portions of the canal in Springdale are now protected by wood covers. All Type D canals were preserved during reconstruction activities.

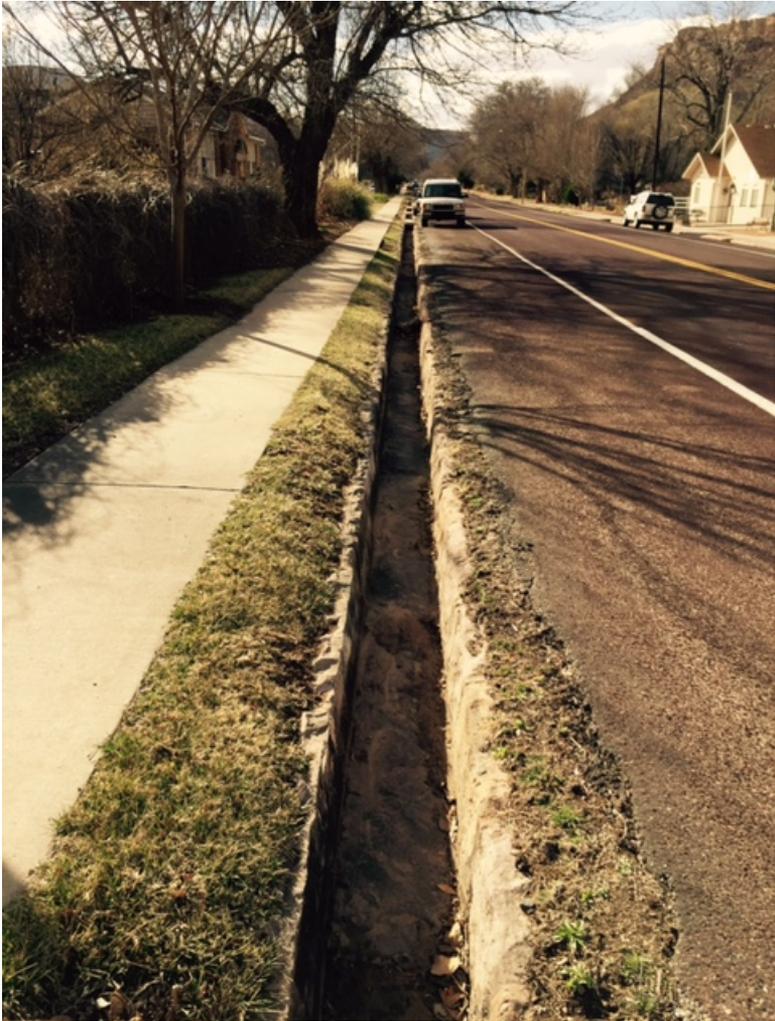
**Figure 22.** Type C “rock-lined ditch,” Rockville.

Another style of feature, designated Type C (**Figure 22**), is a rectangular ditch feature extant only in Rockville on the left side of the road. This type is constructed of square sandstone blocks measuring 12 inches high and 15 inches across, with a level interior base. The 6-inch-thick blocks are level with the road asphalt, resulting in a total feature width of 27 inches. As with Type B, 4-inch-diameter ceramic pipes drained water from the

The design plans refer to this type as a “rock-lined ditch,” but there is a continuous 1,812-foot segment of Type C in Rockville where the plans indicate segments of both Type B and Type C should have been built (USRC 1938 [sheets 81-B3 7, 81-B3 8]). This is one of only two major

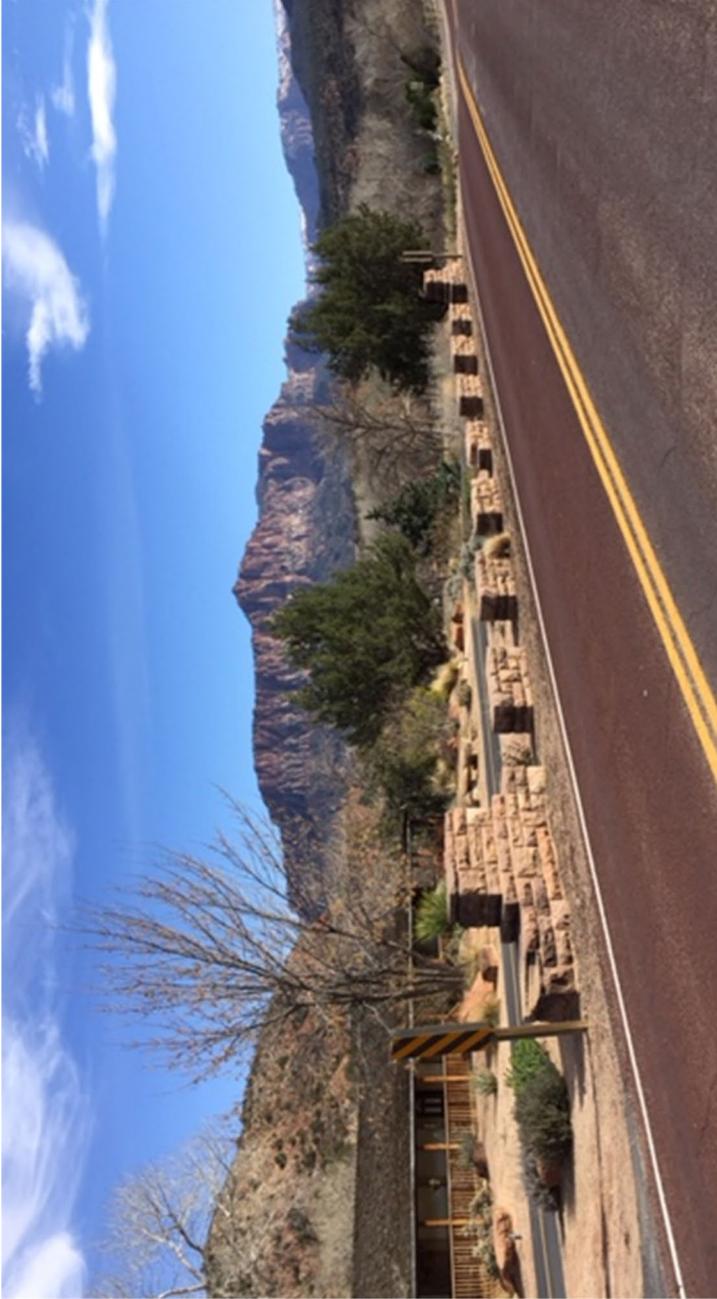
**Figure 23.** Masonry bollards at turnoff entrance at Station 206. View to the southeast.

- Three scenic turnoffs with parapet walls (bollards) near the current Majestic View Lodge (USRC 1938[sheet 81-B3 6]). The roadside bollards at Station 206 are extant and in good condition (**Figure 23**). The other two turnoffs have been either completely or partially demolished

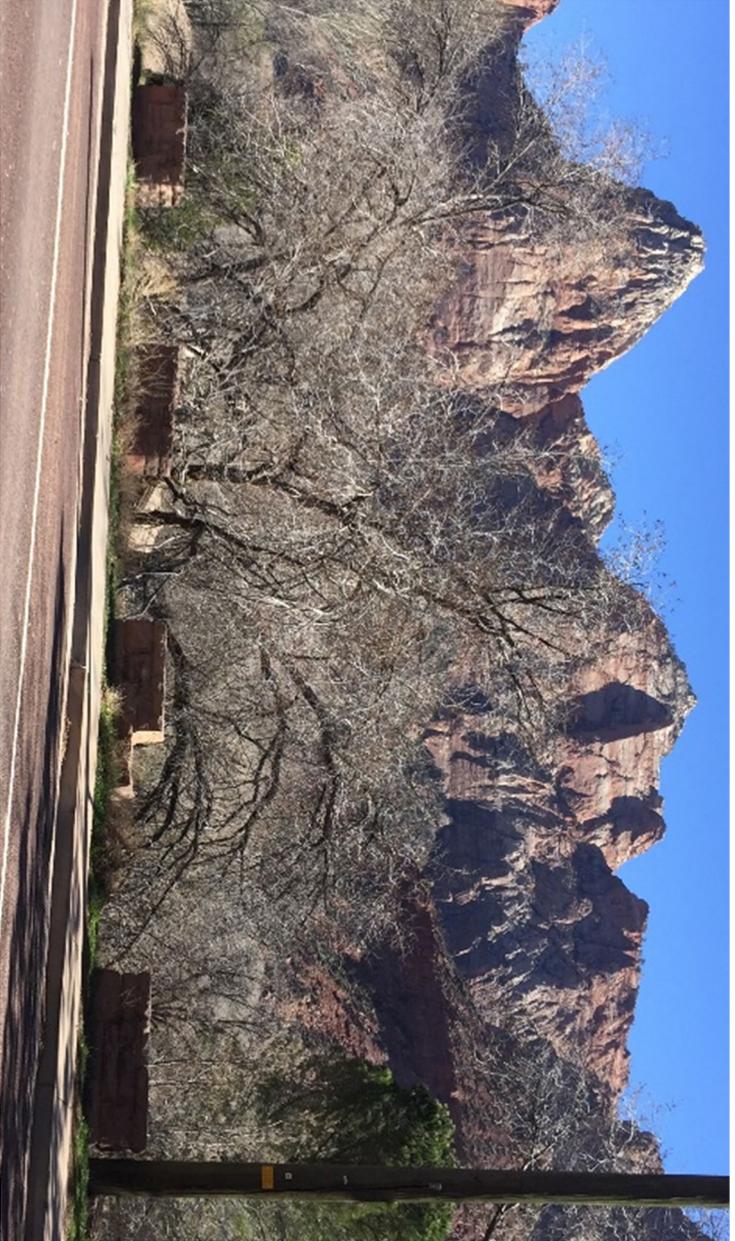
**Figure 24.** Masonry parapet. View to the east.

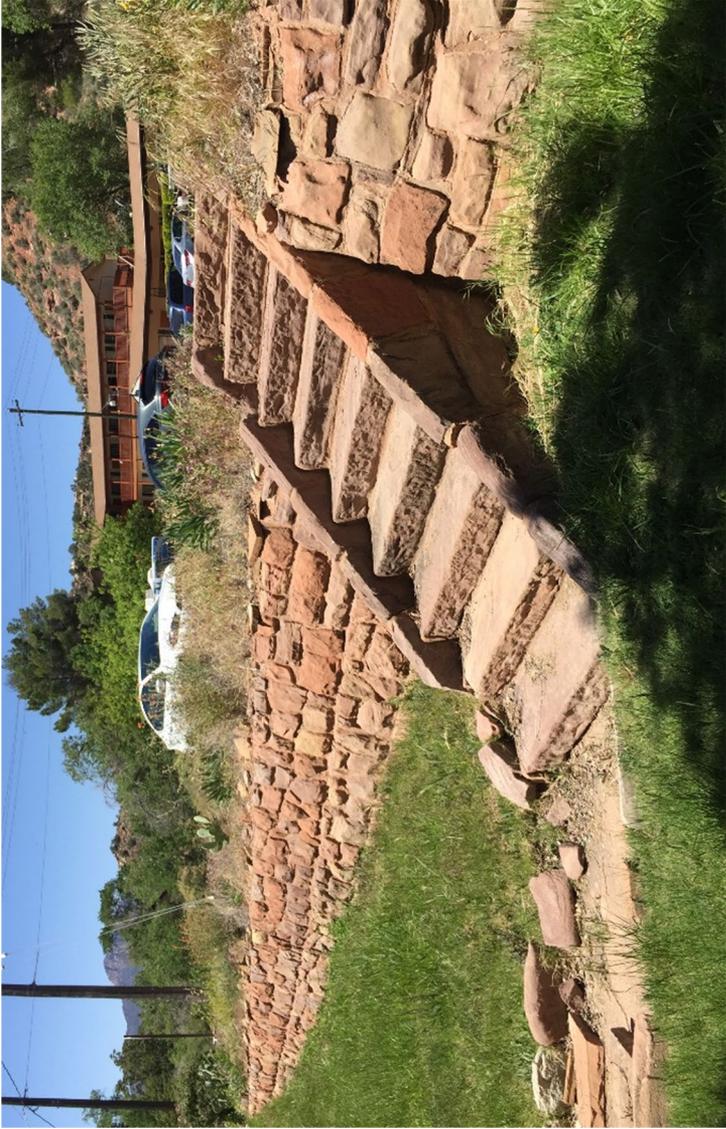
**Figure 25.** WPA-built road retention wall and stone steps. View west from near Sol Foods. This is the highest of the nine sets of steps constructed.

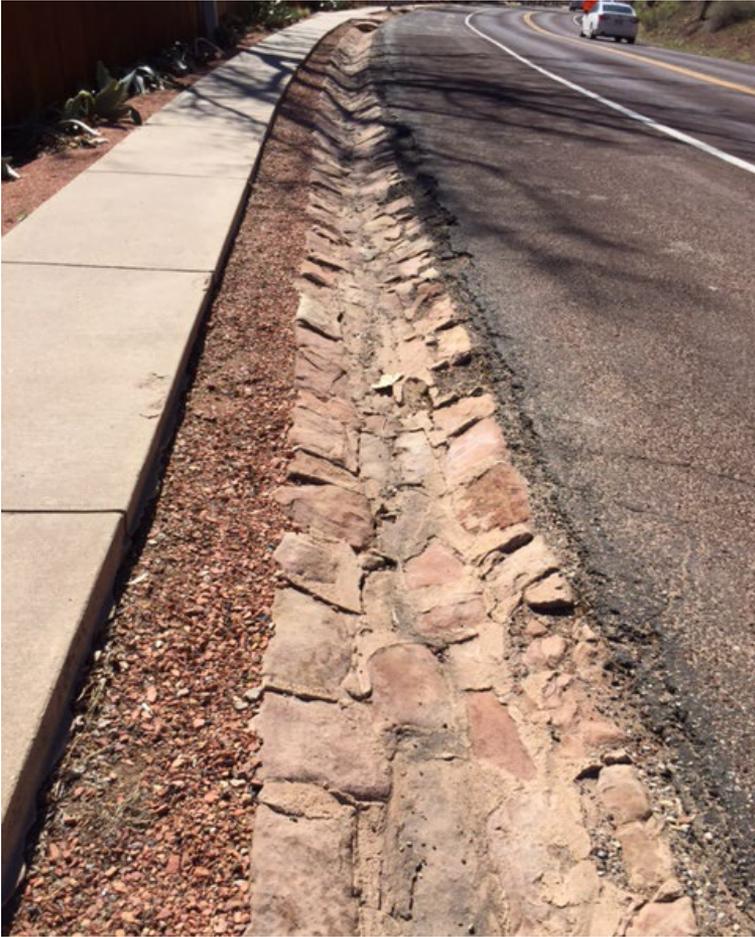
**Figure 26.** 1970s-era gutters installed in Springdale.

Another major change occurred in the late-1970s when the Springdale Consolidated Irrigation Canal Company removed their irrigation system from downtown Springdale and placed the main canal in a pressurized pipe along most of the canal's length. At this time, all Type C "rock-lined ditches" in Springdale were removed (Rawley Johnson and Marion Callister, personal communications 2016). New, shallow gutters were constructed at these locations (**Figure 26**). It is clear from the 1940 to 1941 design plans that these shallow gutters were not part of WPA construction. The longer segments of these new gutters overlapped both the original Type B "gutters" and the Type C "rock-lined ditches" (USRC 1938[sheets 81-B3 3, 81-B3 4]). These new gutters appear to utilize a different rock source, have a softer mortar mix than the WPA features, and show none of the clean pointing or other characteristics of WPA stonework. Marion Callister (personal communication 2016) remembers when the ditches here were removed and the new gutters installed in the late 1970s.
